Clarification on the Internal Structure of Landslide Dam by Microtremor array survey method

Yasuhiro Mitani (Shimane University)
Fawu WANG
Austin Chukwueloka OKEKE
Yohei KUWADA
Taiki ADACHI
Hufeng YANG
Fikri FARIS

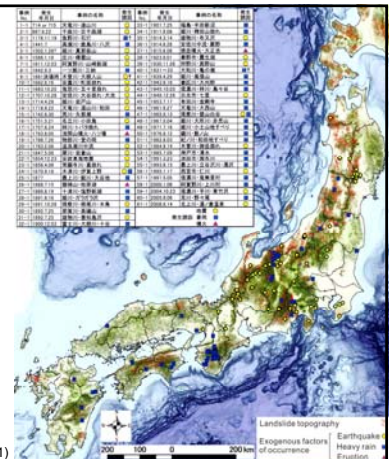
Formation sites of landslide dam in Japan

Formation of landslide dam centers site is related to **topographic** and **geological conditions, natural phenomena** (earthquake, heavy rain, eruption).
